# POTENTIAL HAZARDOUS WASTE SITE SITE INSPECTION REPORT

A. SITE NAME	B. STREET (or other identifier)		
Lufkin Creosoting Company	1411 East Lufkin Avenue		
C. CITY	D. STATE	E. ZIP CODE	F. COUNTY NAME
Lufkin	TX	75901	Angelina

I. SITE DESCRIPTION Abandoned site of Lufkin Creosoting Co.  
Active operations relocated to south of town in 1978.

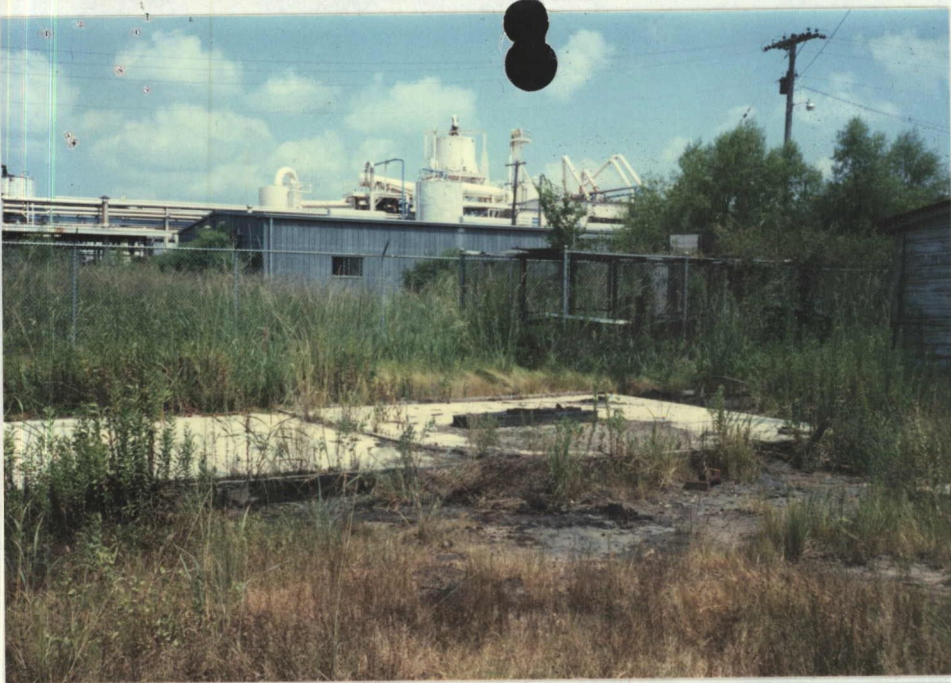
①

Comments: Old storage tank area.  
Note the blackened soil to  
the right of the concrete pad.

Around the tank farm area a 3-inch thick concrete pad was observed. No containment walls were observed and the soil on the west side of the pad was black and oily with distressed vegetation.

Because of the concentration of creosote found off site (where the background sample was collected) and in the upgradient on-site sediment sample, the site is given a medium hazard ranking. A follow-up site inspection is recommended to assess the extent of creosote contamination on site (in the drainage ditch and old tank farm) and off site.

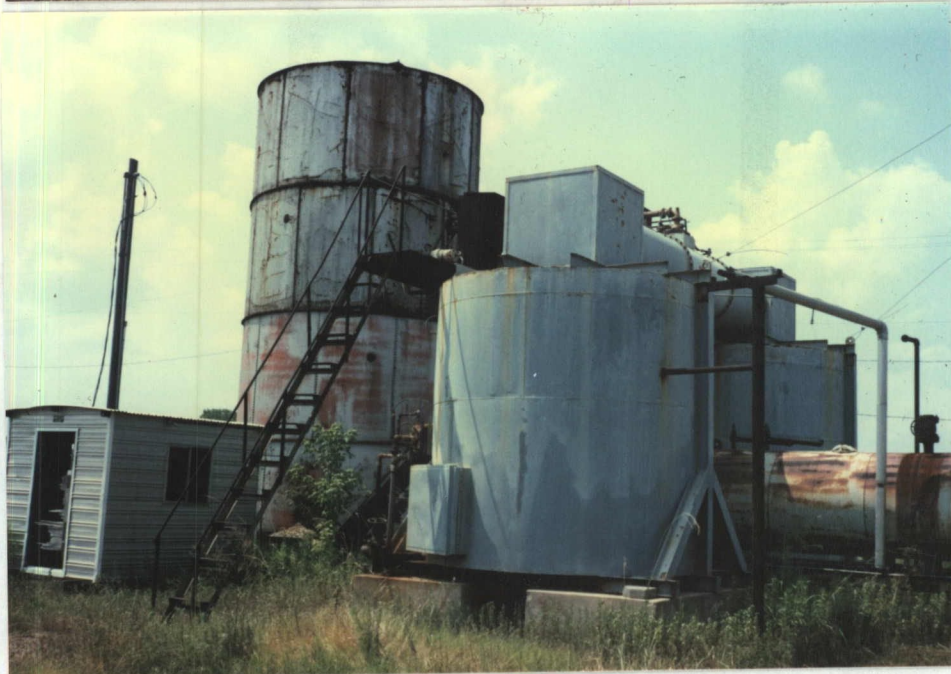
②

Comments: Boiler left on site.  
after the facility was closed.

A site reconnaissance with Mr. Vines was begun at the old site after the interview. Equipment observed on site included a boiler and 4 120-foot treatment cylinders. The cylinders were reportedly a recent purchase from the west coast and were being stored at the site. A large drainage ditch traversed the prop-

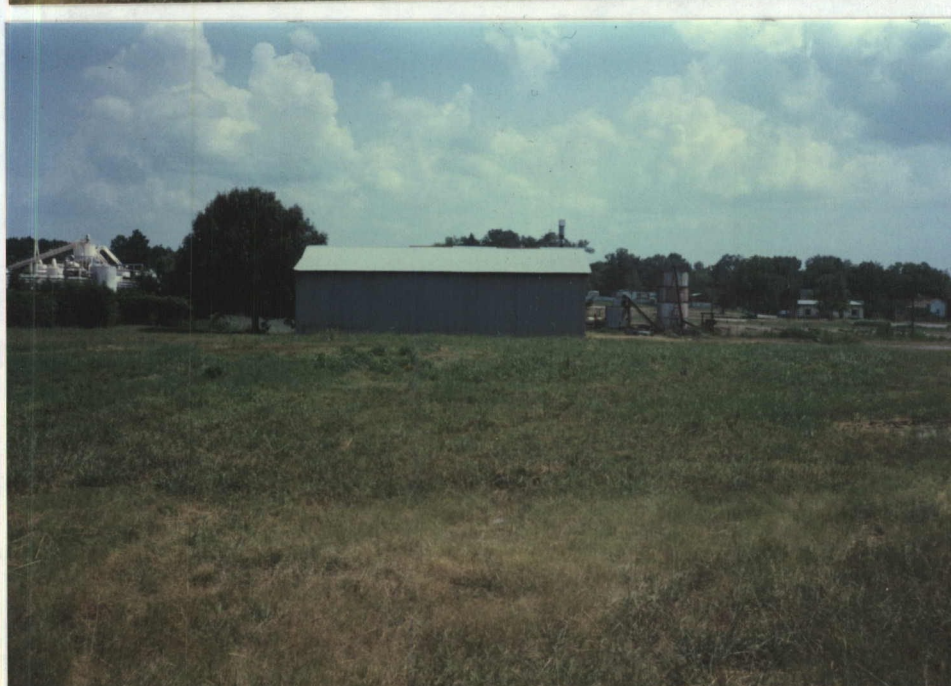
③

Comments: Abandoned surface  
impoundment, filled with soil.  
(Foreground) Barn in background.

The surface impoundment had been used for blowdown water and was contaminated with creosote. The size of the impoundment was approximately 80' x 150' x 28". It was closed in 1973-1974 without TWC enforcement or supervision by pushing the embankment soil over the surface. Grass was observed growing over the closed impoundment.

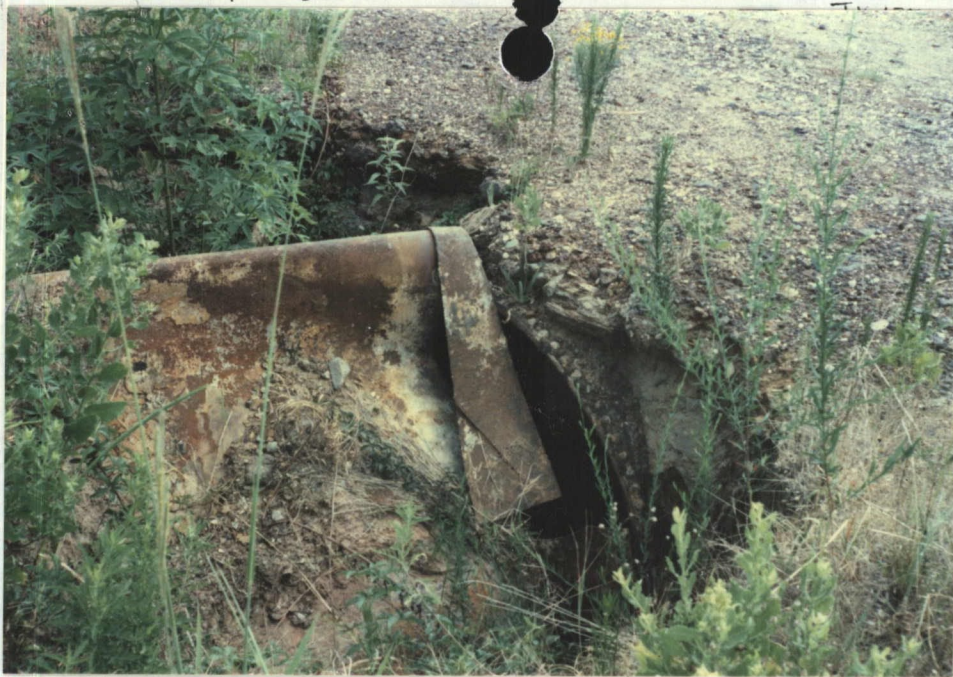
(4)

Erosion observed along the culvert (part of the drainage ditch) on the east side of the site.

Comments: Culvert near plant  
road split at the seam. Blackened  
soil visible in the 3-6 inches of  
soil below the surface.

erty in an east to west direction with a portion enclosed in a culvert. The culvert was made of 6000 gallon steel diesel storage tanks welded together. Erosion channels were observed along the length of the culvert and blackened soil was observed at 3-6 inches from the surface within the channels. Black stains were seen on the sediment and grasses in the open portion of the drainage ditch. Water was flowing slowly in the ditch and had a blackish color and an oily sheen.

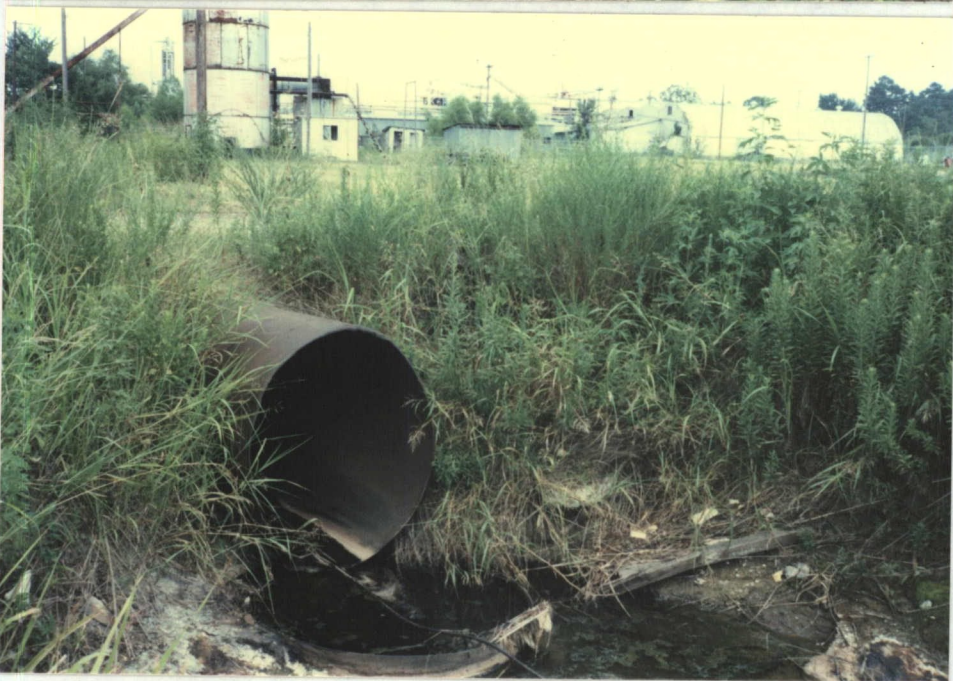
(5)

Drainage ditch traversing site visually appeared to be contaminated with creosote constituents. Surface water in ditch had an oily sheen.

Runoff of an oily sheen observed in drainage ditch traversing the site.

Comments: Drainage from the  
culvert.

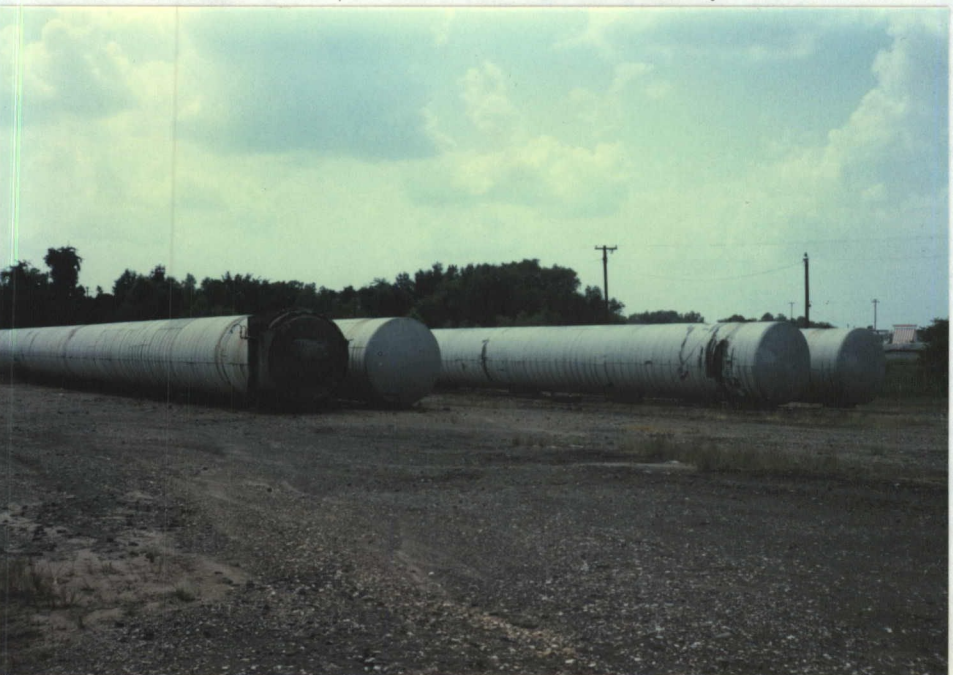
(6)

Comments: Four 120 foot treatment  
cylinders stored at the site.

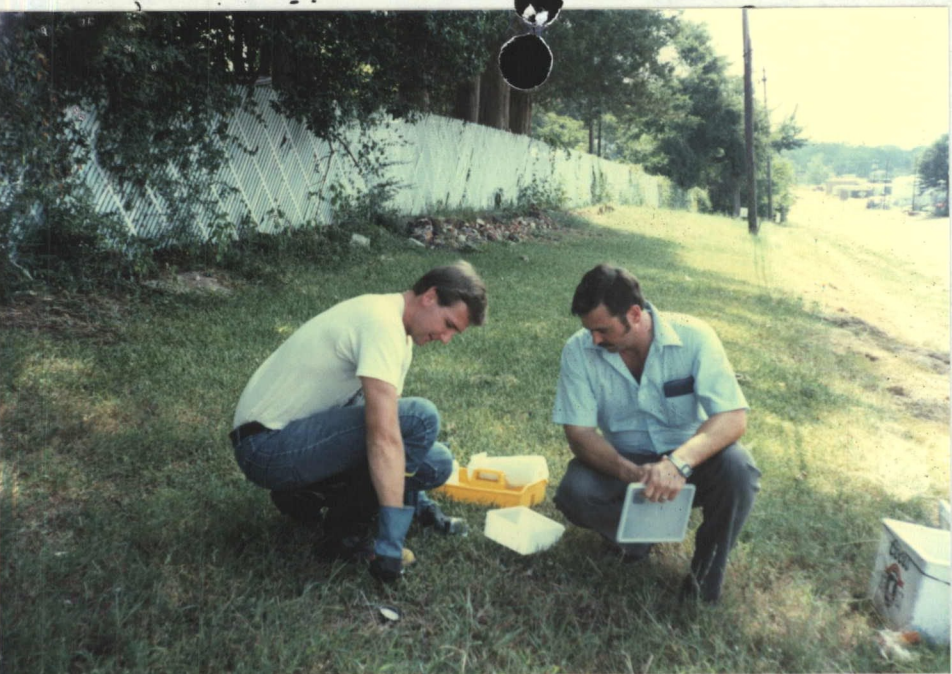
(7)

Comments: Background soil (TX13765-1)  
Vines split soil samples.

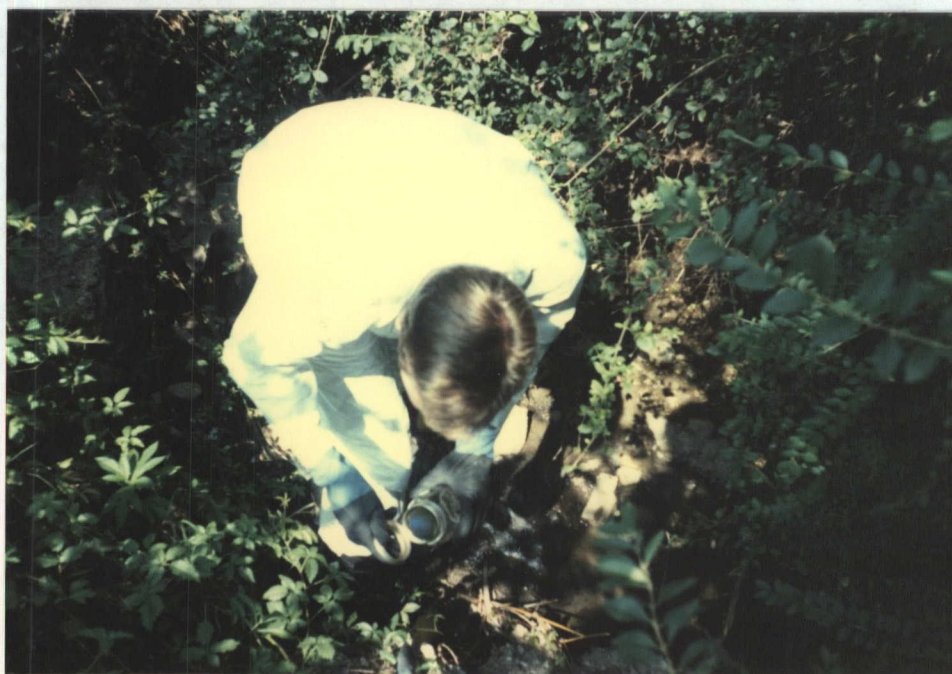
(8)

Comments: Upstream sediment  
(TX13765-2) -  
in drainage ditch Inside Mr  
Vine's property line.

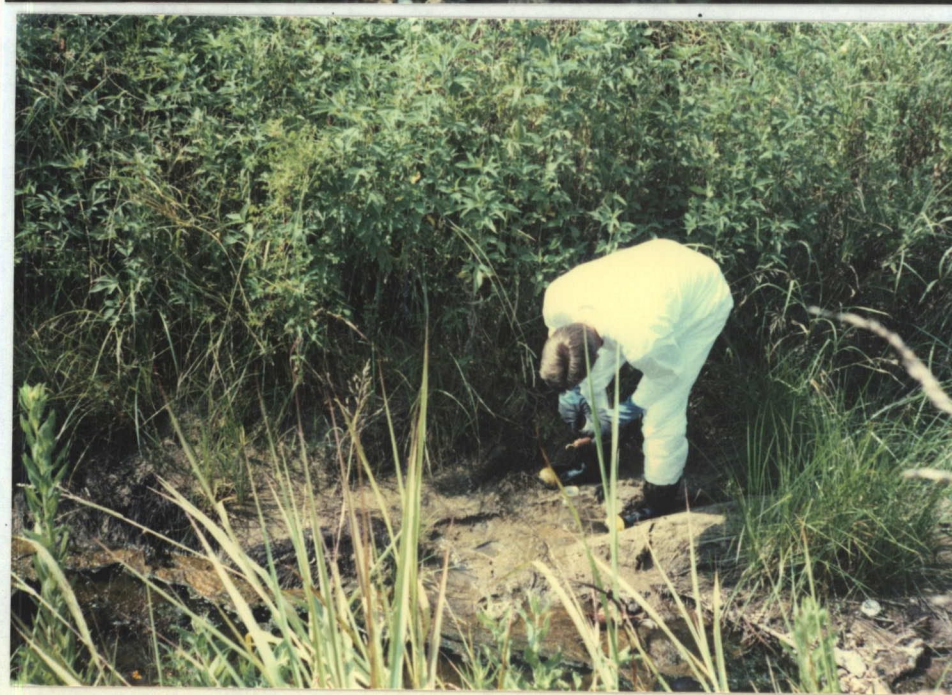
(9)

Comments: Downstream sediment  
(TX13765-3) -  
samples Black stains on the  
ground & grass.

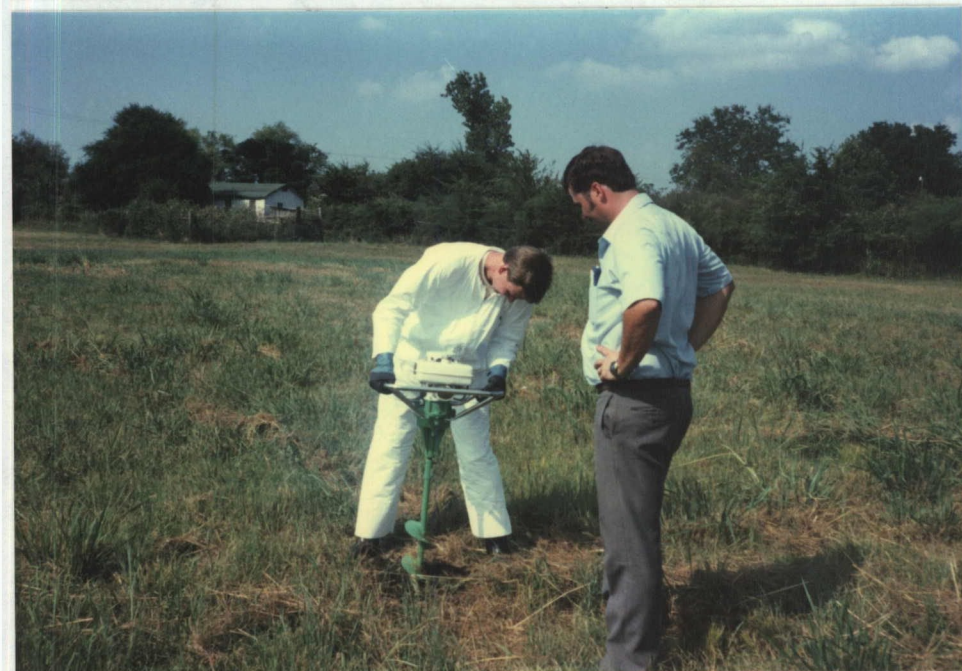
(11)

Comments: Old surface impoundment  
location. Augering for sample

Soil samples were collected from the drainage ditch and the closed impoundment. A background soil sample was collected across Lufkin Blvd. south of the site. Mr. Vines split samples at each sample location. An "upgradient" sediment sample from the drainage ditch was collected from the middle of the ditch at the east property line and inside Mr. Vines' property. As the sample was collected black oily waste surfaced and floated on the water. The downstream sediment sample was collected in the middle of the open ditch. Black oily sediment was noted in the sample at a depth of approximately 5 inches below the surface. A subsurface soil sample was collected at about 2 feet below the surface at the closed surface impoundment. At this depth a very clayey black sludge with a creosote odor was encountered.
